Investigation on Offshore Floating Mooring Chains Failure

Submitted: 6 October 2022 / Accepted: 12 October 2022
© ASM International 2022

The current study is on a 150-m chain which is composed of five studded links, 30 m each, connected to each other using a shackle. This mooring system was installed at the red sea near a region called Abou Zenima. This chain is attached to a 4 tons anchor on the seabed, and to a single buoy mooring link on the other end. After only three days of installation, the chain fractured at the single buoy mooring link end, near the midway of the first free chain link, see Fig. 4a. The environmental conditions associated with the failure are wind speed of ± 23 m/s, and NNW at swell ± 2.5 m. The chain fractured at the locations where the crown and shank intersected, as shown in Fig. 4. The broken chain was investigated by visual examination, metallographic examination, and scanning electron microscopy.

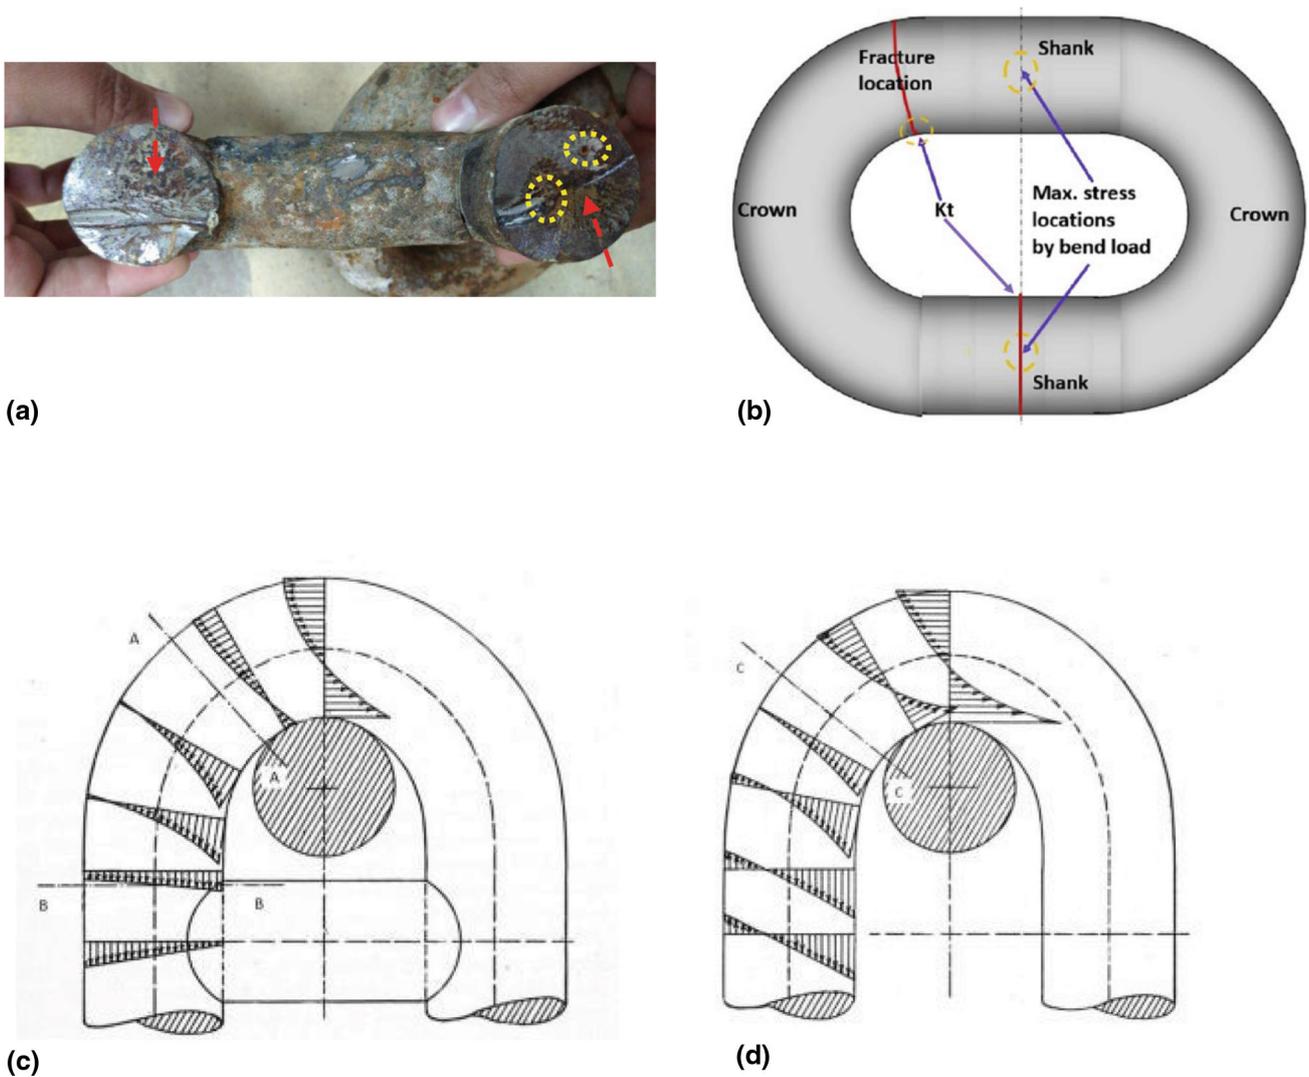
Observation of the fracture surface of the failed chain was conducted to understand the possible failure mechanism. As illustrated in Fig. 4a, the surface examination of the fractured surface of the chain revealed a brittle and a corroded surface (left side) where crack propagates from top to bottom as illustrated in Fig. 4a by red-dashed arrow. On the other hand, fracture at shank zone also showed a brittle manner with corrosion pits near the center of the chain, see yellow-dashed circles in Fig. 4a (right side).

Optical micrographs of the investigated samples show the presence of ferrite and pearlite, see Fig. 6. Corrosion pits filled with iron oxides were also observed on the chain fracture surface, illustrated in Figs. 4a and 6. These pits were formed due to corrosion which is accelerated due to

Fig. 4 (a) Fractured chain link, (b) Schematic of link chain stresses and fracture locations, (c) bending, and (d) tensile distribution of stresses in a chain [9]

presence in sea water environment. Local pitting corrosion is mostly observed in the submerged near-surface zone which initiate around inclusions of MnS and TiVCr [11]. These pits cause significant mass loss resulting in local stress concentration and initiate cracks under force which lead to accelerated degradation of the mooring chains.

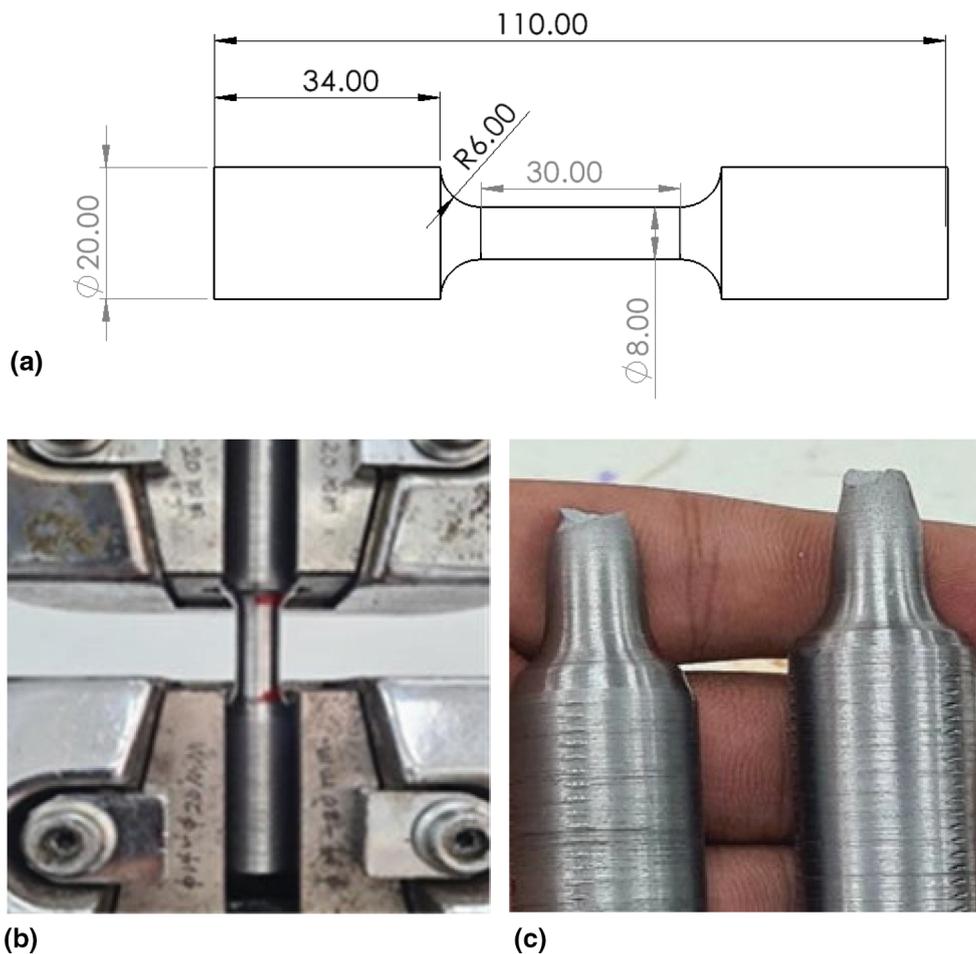
Figure 5c illustrates that the fracture surfaces of the tensile sample is ideal cup and cone fracture which indicates ductile behavior when overloading. This was verified

Fig. 5 (a) Schematic drawing for tensile test sample, (b) and (c) tensile test sample before and after test

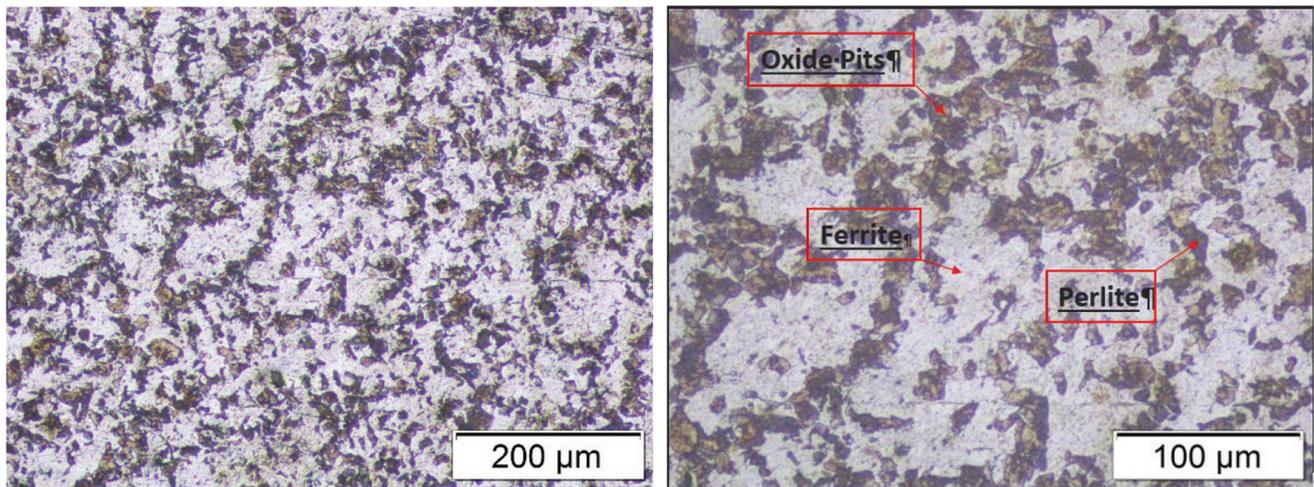
Fig. 6 Optical micrographs of chain link sample

- The microstructure confirmed that the material is low carbon alloy steel with ferrite and perlite grains along with iron oxide pits, which would be presumed to have made the material rather brittle.
- It was concluded that the failure might be due faulty material as chemical composition not conforming to the specified steel grade.
- Although, the fracture on the tensile sample shows ductile features, the fractographic analysis of the failed part reveals that the chain was fractured catastrophically in a brittle manner.
- FEA results are in accordance with the fractographic analysis.
- The results of finite element analysis of R3 steel show that the stress magnitude caused by OPB forces is 15% greater than that of ultimate tensile strength.
- R4 steel shows safer design compared to R3 steel.

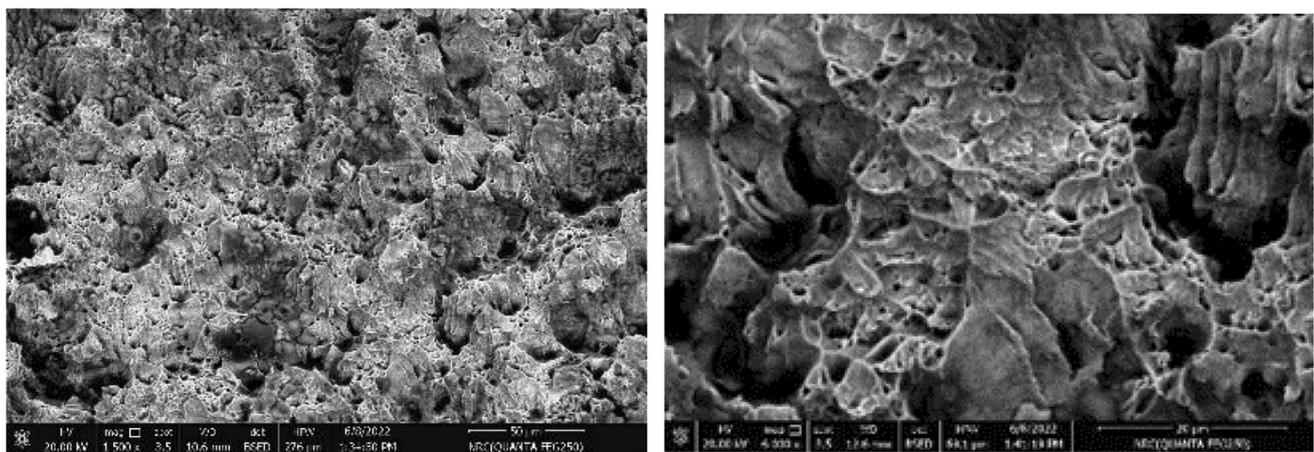
with SEM images for the tensile fracture surface which shows equiaxed dimples indicating a ductile fracture manner, see Fig. 7.

Fig. 7 SEM images of fracture surface of tensile test sample at different magnification

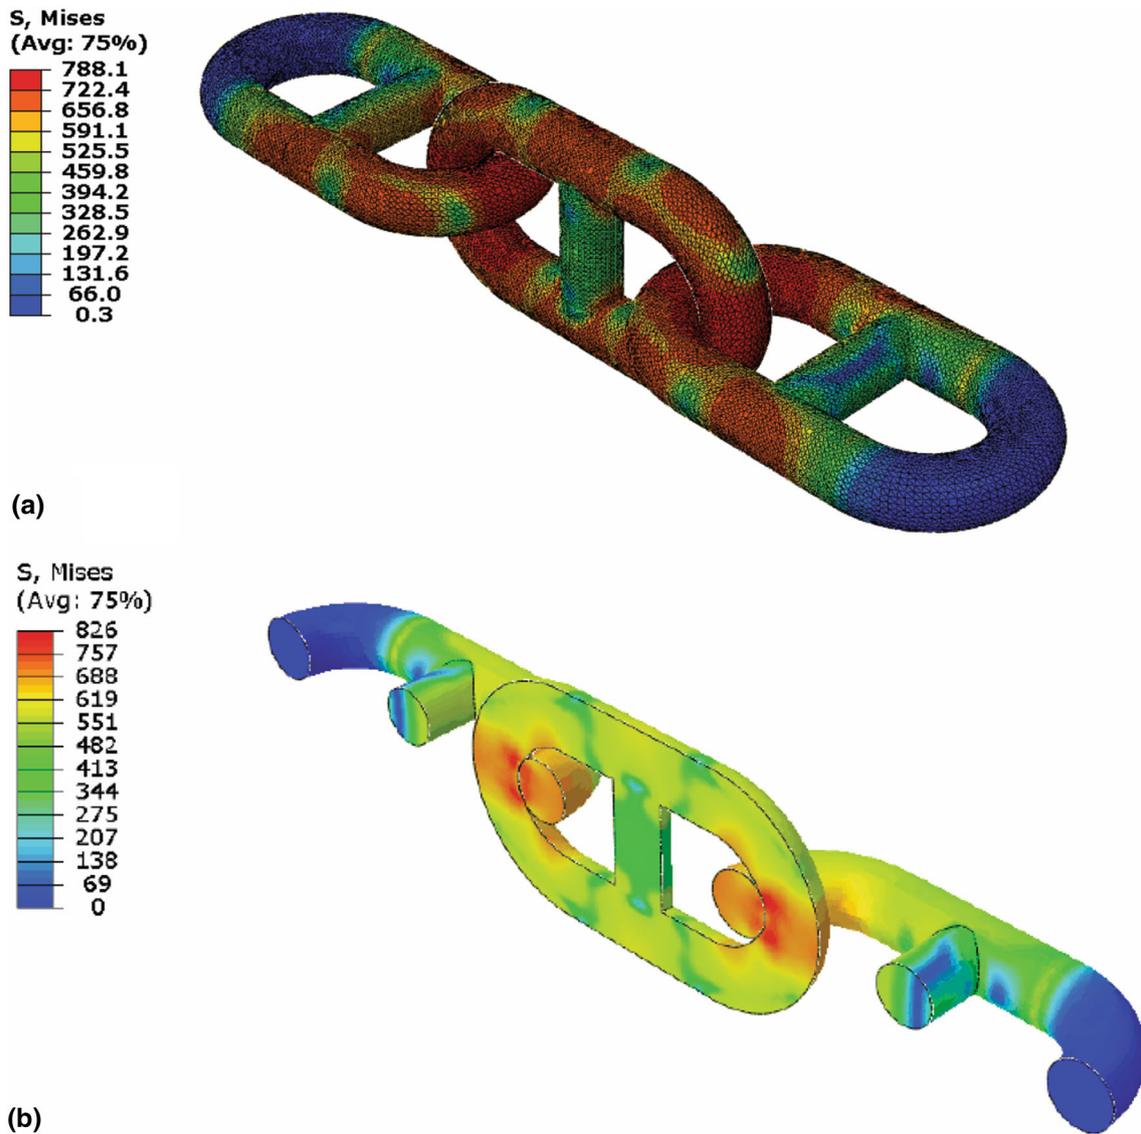
accuracy of the results to be near the true conditions of the chain. Figure 10a shows the results of the ABAQUS analysis when conditions are met. From the numerical analysis, the results show that the maximum Von-Mises stress is around 790 MPa which exceeds the breaking load of R3 steel. Therefore, red marked zones are considered

possible location for fracture to occur. These locations are the same exact location where the actual failure occurred. On the other hand, using R4 steel, which has a higher UTS of 860 MPa, shows a safer design for material selection, as the stresses generated at the same conditions compared to R3 steel are lower than breaking load of R4 steel.

Fig. 10 Von-Mises stress distribution (a) R3 steel and (b) R4 steel
