Investigation on Offshore Floating Mooring Chains Failure

Submitted: 6 October 2022 / Accepted: 12 October 2022
© ASM International 2022

The current study is on a 150-m chain which is composed of five studded links, 30 m each, connected to each other using a shackle. This mooring system was installed at the red sea near a region called Abou Zenima. This chain is attached to a 4 tons anchor on the seabed, and to a single buoy mooring link on the other end. After only three days of installation, the chain fractured at the single buoy mooring link end, near the midway of the first free chain link, see Fig. 4a. The environmental conditions associated with the failure are wind speed of ± 23 m/s, and NNW at swell ± 2.5 m. The chain fractured at the locations where the crown and shank intersected, as shown in Fig. 4. The broken chain was investigated by visual examination, metallographic examination, and scanning electron microscopy.

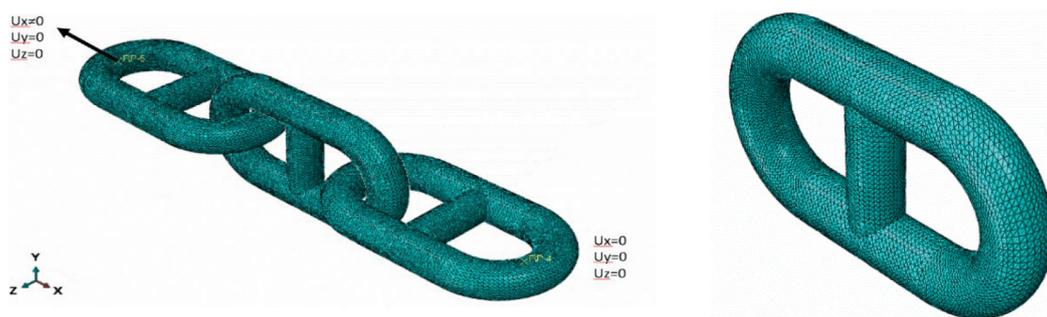
for finite element simulation. The finite element model, represented in Fig. 8, was created using a 3-chain links taking into consideration that every link is considered and treated as an individual link. The first step in the model was to insert accurately the material properties. The model has defined elastic and plastic data for deformation of the material, as shown in Fig. 9. The elastic and plastic data inserted for R3 steel is extracted from the data obtained from the tensile test.

3D computational domain was defined in the model to define the solver as explicit dynamic solver to accurately solve the computational analysis of the model. Thus, each link of the chain is discretized with 8 node linear brick solid, reduced integration elements (C3D8R). Figure 8 shows the mesh of the full assembly of the chain presented with the boundary condition. Two reference point are created with the chain's links using a coupling constrain. The chain is fixed from one of its free ends while the other end is given a displacement along the link direction. The displacement boundary condition is created on these two reference points. Figure 8 also illustrates the mesh of the assembly. Which was created on the links individually, every part includes 165,824 element and 31,364 nodes. Which in total of the assembly around 600,000.

Fig. 8 3D models of mooring chain
